BOW AVIATION, LLC
16112 PARK PLACE
BOW, WA 98232
(360) 202-3869

AIRCRAFT APPRAISAL REPORT

This is a Reconstructive Appraisal for Taylorcraft N27W.

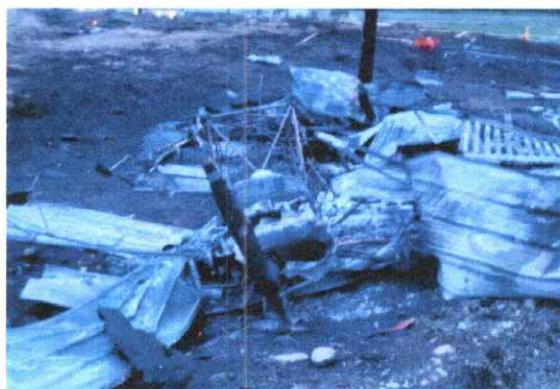
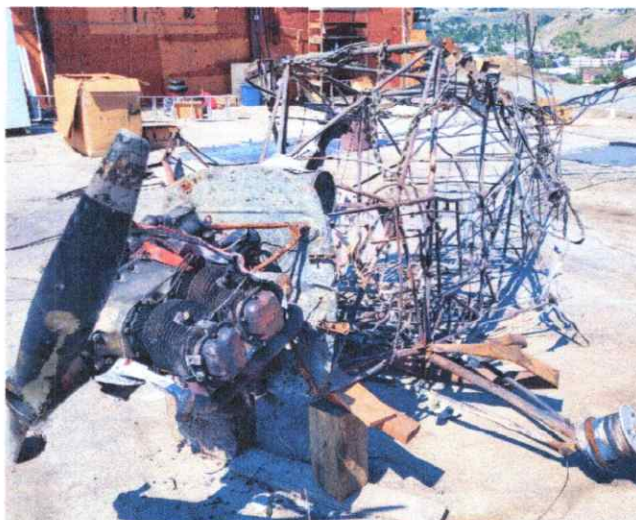
Current Damage: Aircraft destroyed in hanger collapse and fire.
